## PART# 8985, 8989 Part# 8985 TH700-R4 Braided TV Cable Part# 8989 TH350 Braided TV Cable

## TH700-R4/TH350 THROTTLE VALVE (TV) CABLE WARNING: SEVERE DAMAGE MAY OCCUR IF TV CABLE IS NOT ADJUSTED CORRECTLY

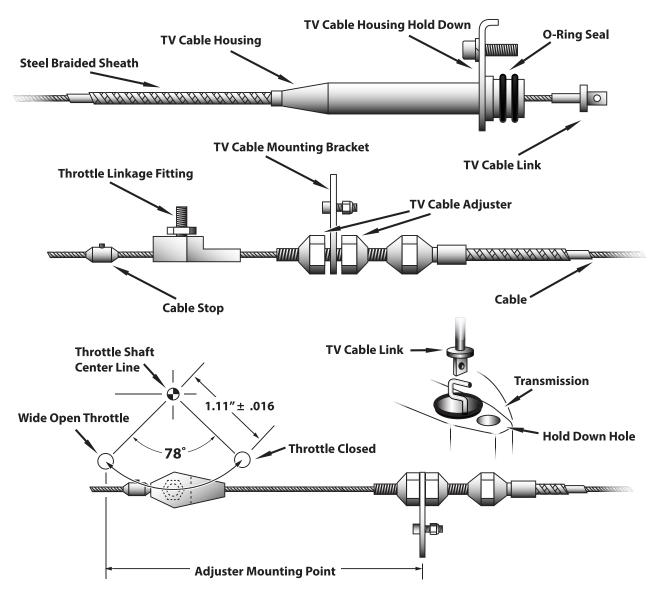
**IMPORTANT:** Follow diagram below. Be sure the TV cable movement feels free and is consistent with the measurements stated. It is **VERY** important that the cable operates within these parameters. Damage may occur if not adjusted correctly.

**NOTE**: CHECK CABLE PERIODICALLY AND REPLACE IF THERE ARE ANY SIGNS OF WEAR OR KINKING OF THE HOUSING OR WIRE. AS THIS COULD CAUSE THE CABLE TO STICK OR FAIL CAUSING INJURY OR DAMAGE.
